1998 Lexus LS400

DRP3-01

| DTC | B2791/99 | Key Unlock Warning SW OFF Malfunction |

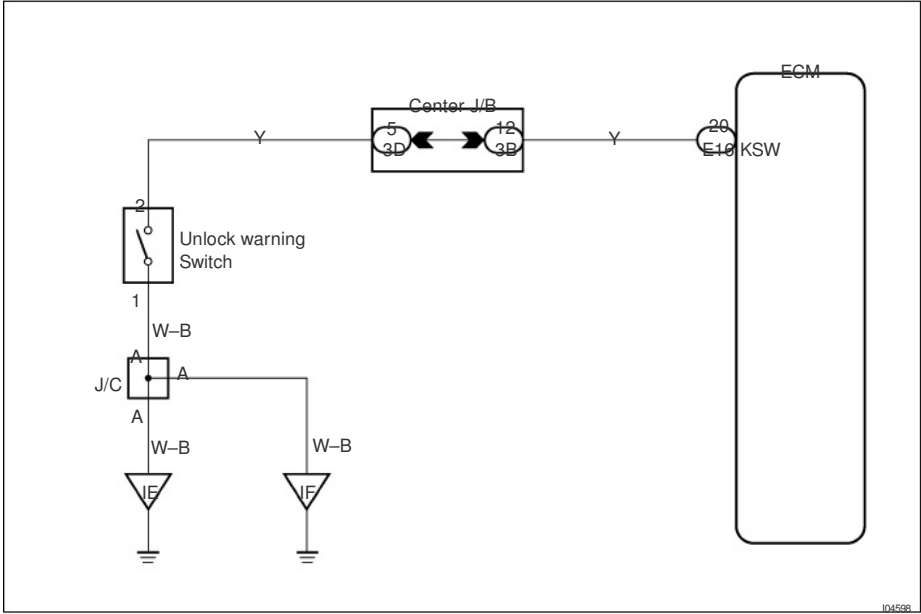
WIRING DIAGRAM

| DTC No. | DTC Detecting Condition | Trouble Area |
|---|---|---|
| B2791/99 | • Open circuit in key unlock warning switch circuit.<br>• Key unlock warning switch adheres to OFF position. | • Key unlock warning switch<br>• Wire harness |

Check harness and connector between key unlock warning switch and ECM (See page [IN-30](#)).
