## BRAKE PEDAL ON-VEHICLE INSPECTION

2005 LEXUS IS300 (RM1140U)

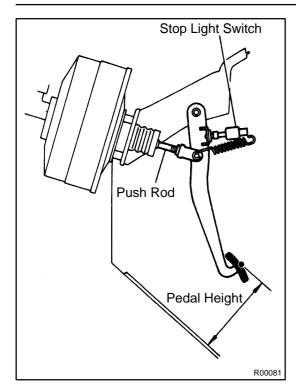
1. CHECK PEDAL HEIGHT

Pedal height from asphalt sheet: 154 - 164 mm (6.063 - 6.457 in.)

- 2. IF NECESSARY, ADJUST PEDAL HEIGHT
- (a) Remove the lower finish panel (See page BO-135).
- (b) Disconnect the connector from the stop light switch.
- (c) Loosen the stop light switch lock nut and remove the stop light switch.
- (d) Loosen the push rod lock nut.
- (e) Adjust the pedal height by turning the pedal push rod.
- (f) Tighten the push rod lock nut.

Torque: 25 N-m (260 kgf-cm, 19 ft-lbf)

- (g) Install the stop light switch and turn it until it slightly contacts the pedal stopper.
- (h) Connect the connector to the stop light switch.
- (i) Push in the brake pedal 5 10 mm (0.20 0.39 in.), turn the stop light switch to lock the nut in a position where the stop light goes off.
- (j) After installation, push in the brake pedal 5 10 mm (0.20 0.39 in.), check that stop light lights up.
- (k) After adjusting the pedal height, check the pedal free play.
- (I) Install the lower finish panel (See page BO-135).
